RECONSTRUCTION OF HIT-AND-RUN VEHICLE TYPE BASED ON UN-COMMON RUN-OVER INJURIES

Vidanapathirana M¹, Gunethilake K.M.T.B.²

¹Department of Forensic Medicine, Faculty of Medical Sciences,
University of Sri Jayewardenepura, Sri Lanka and

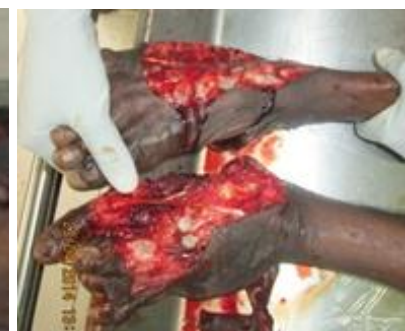
Autopsy revealed that the body was clad in a sarong and a long sleeved shirt and the clothes had dust and mud stains but no tire marks. There were no paint or glass fragments in the clothes and the body. There were three groups of injuries (Figure 1); transversely placed crushed lacerations and underlying fractures in feet (Figure 2), almost transversely placed elongated large

Figure 2: Crushed feet

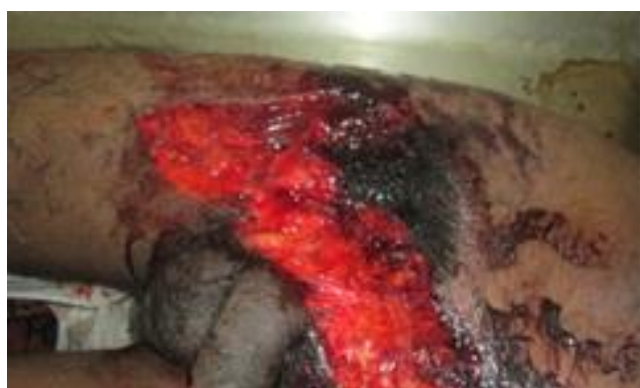
crushed laceration over the pubic area of the pelvis with underlying major vessels damage including right femoral vessels. (Figure 3), and superficial abrasions over knees (Figure 4). Distance from feet to knee injuries was 23 inches and to pelvic injuries 46 inches.

Figure 3: Crushed laceration over the pelvis

Absence of underlying pelvic fractures or severe internal organ damages were more compatible with wheels of a light vehicle such as three-wheeler rather than a supermini, subcompact⁵ or light car such as Maruti 800 where the width of wheels is about 4 and half feet (56 inches)⁵.

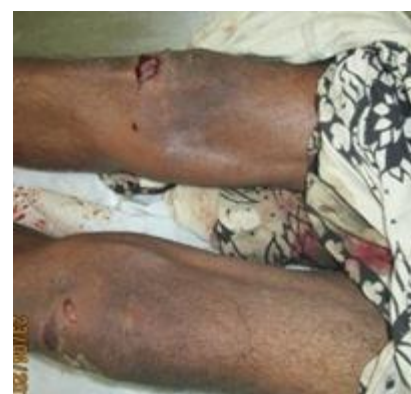
Figure 4: Superficial injuries on knees

Injuries over knees were not severe and were situated midway between the two severe injuries and were compatible with front tire of a three-wheeler. Less severe injuries by

front tire could be due to less weight exerted on it.
